EXHIBIT B ASBESTOS REPORT

Re: Limited Asbestos Sampling
Proposed Olympic Museum Project
220 & 230 South Sierra Madre Street
Colorado Springs, Colorado
Terracon Project No. 23157016

Limited Asebstos Sampling Report

**Asbestos Demolition Inspection
South Sierra Madre Warehouses
Colorado Springs, Colorado**

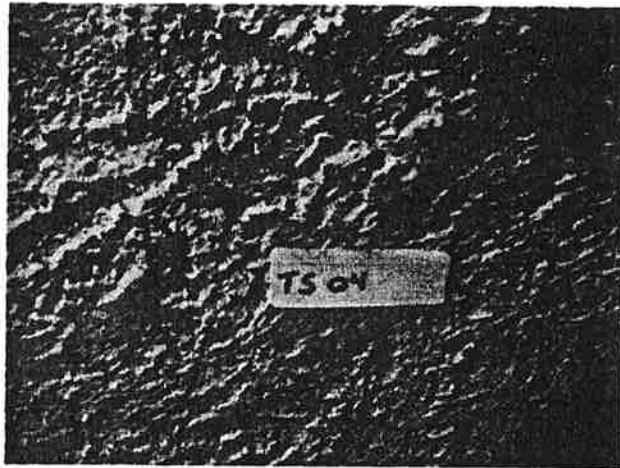
3.1.12 220-TS04: Textured Surfacing – Heavy Knockdown

The textured surfacing was found to contain 10% Chrysotile asbestos. This material is located on the North, East and South exterior walls of the building.

Friable ACM was confirmed in heavy knockdown located on exterior of building, and in trowel applied wall texture over cement blocks located on pillars and interior walls. Friable ACM is regulated by federal and state laws and must be removed prior to renovation or demolition activities.

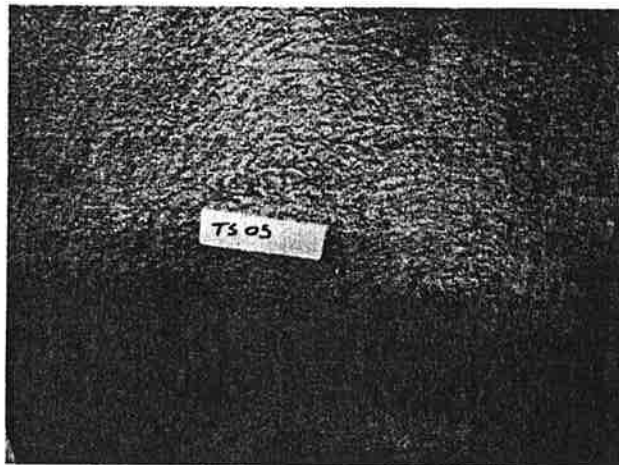
3.1.13 220-TS05: Textured Surfacing – Trowel Applied and Cementitious

The cementitious texture was found to contain 5% Chrysotile asbestos.
